1 Example St, Brisbane QLD 4000, Australia

Company Name: ARIS Detect

Executive Summary

Roof Information - Default - Main Roof

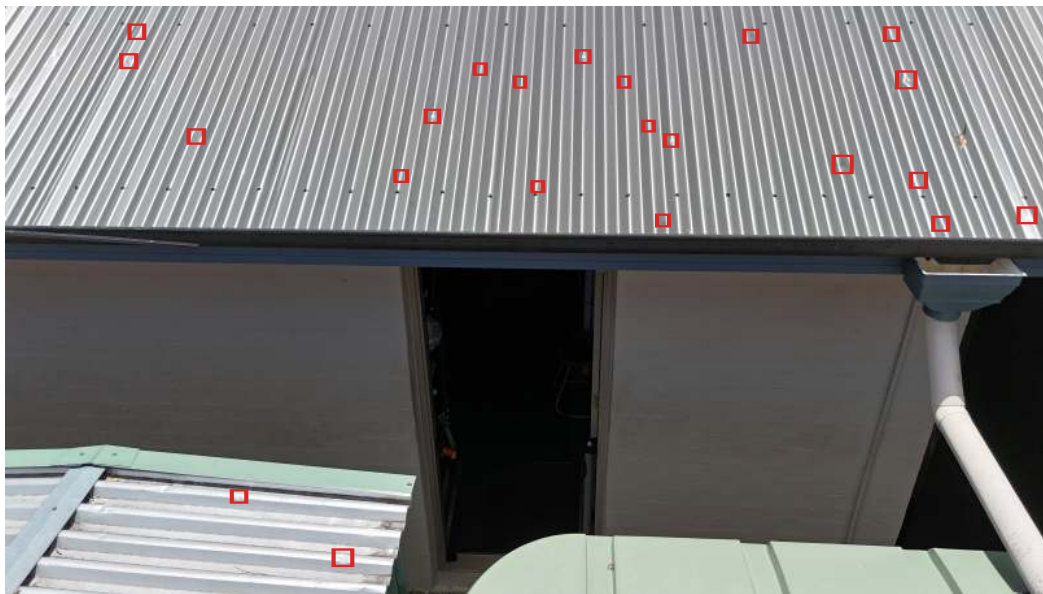
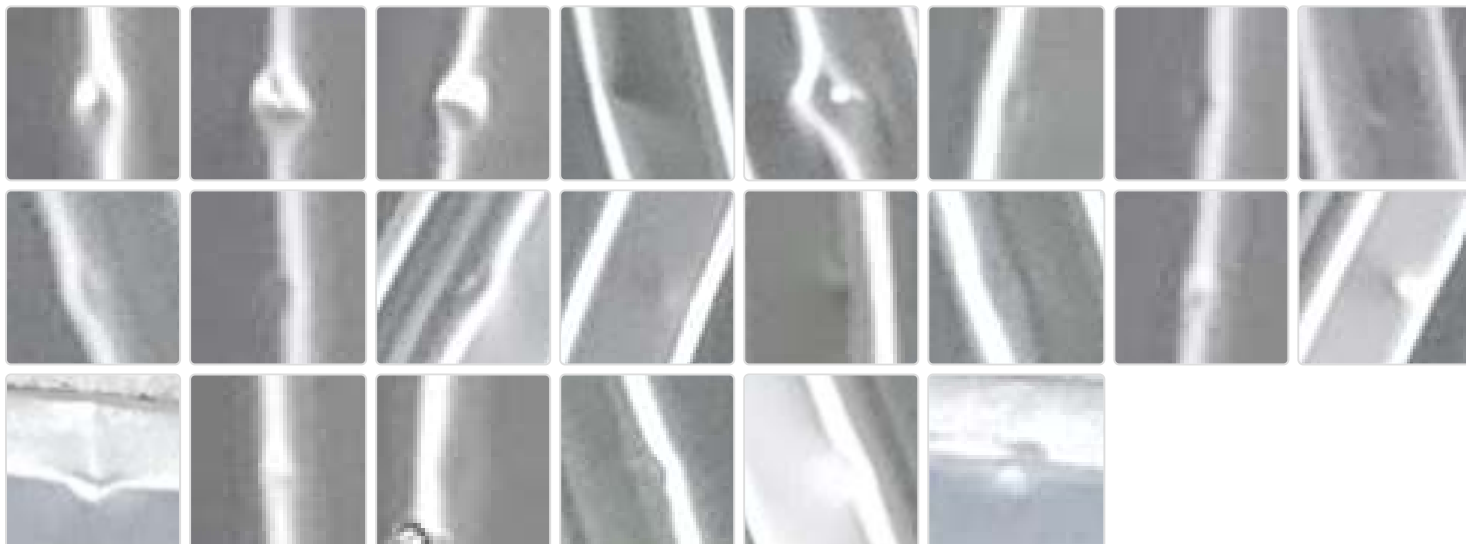
Lat: -27.5605808
 Lon: 152.9012091

● Hail Hit 22

● Hail Hit

insurable

Description: Hails Hits have caused dents in roof & or sheet metal sheeting that can affect the structural integrity of the material depending on the size, location, and severity of the dent.

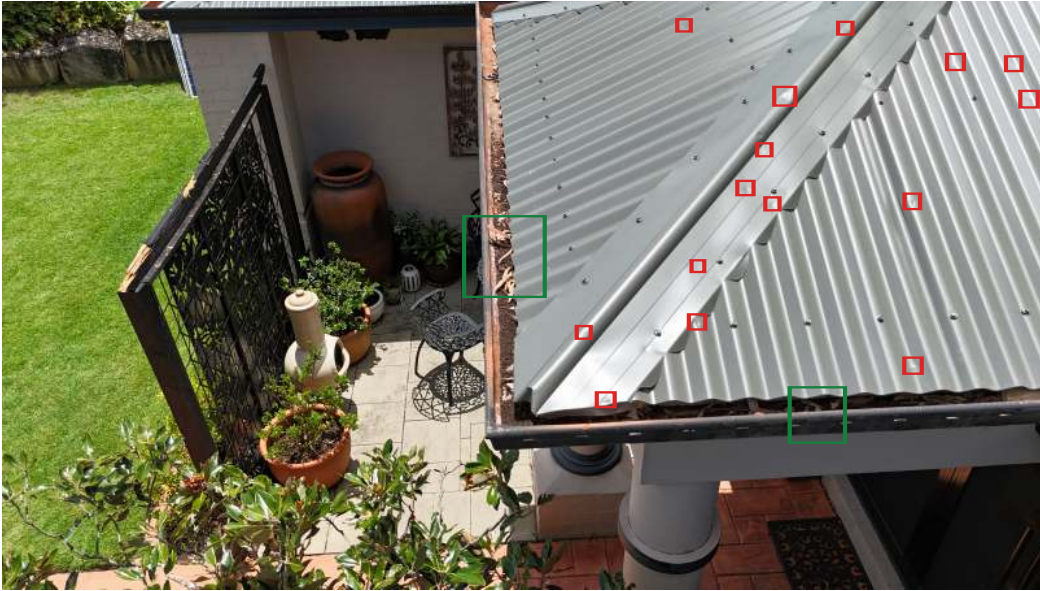
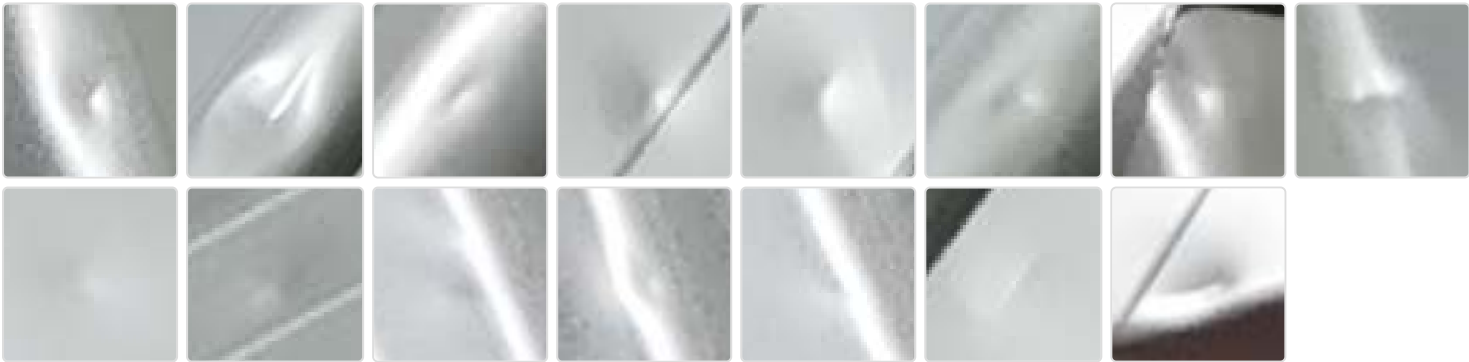
Lat: -27.5604869
 Lon: 152.9012165

- Organic Debris 2
- Hail Hit 15

● Organic Debris

[maintenance](#)

Description: The accumulation of organic matter can block roof sheet pans, gutters, and down pipes, reducing the efficacy of the drainage system. Organic matter holds moisture, creating a corrosive environment, which accelerates the degradation of the roof, and drainage system.

● Hail Hit

[insurable](#)

Description: Hails Hits have caused dents in roof & or sheet metal sheeting that can affect the structural integrity of the material depending on the size, location, and severity of the dent.

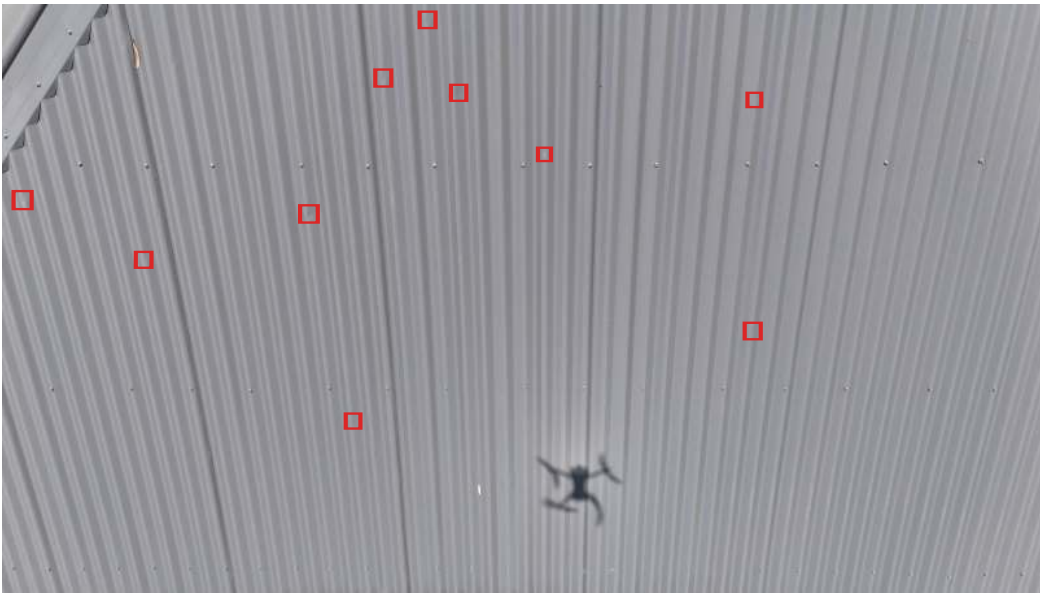
Lat: -27.5605398
Lon: 152.901185

Hail Hit 10

Hail Hit

insurable

Description: Hails Hits have caused dents in roof & or sheet metal sheeting that can affect the structural integrity of the material depending on the size, location, and severity of the dent.

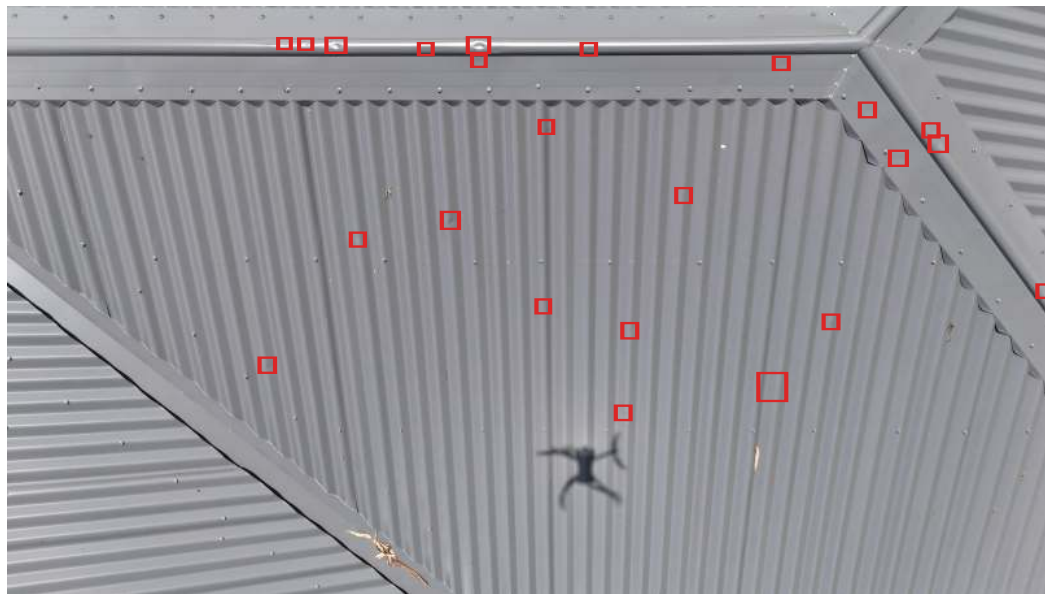
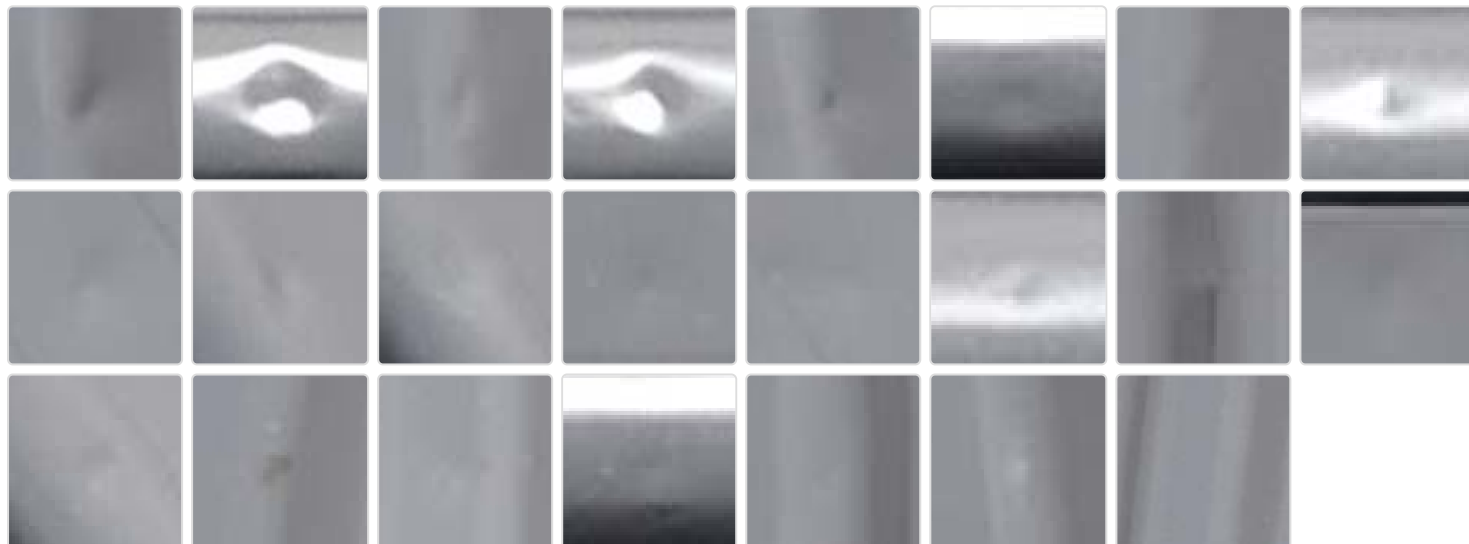
Lat: -27.5605113
 Lon: 152.9013406

● Hail Hit 23

● Hail Hit

insurable

Description: Hails Hits have caused dents in roof & or sheet metal sheeting that can affect the structural integrity of the material depending on the size, location, and severity of the dent.

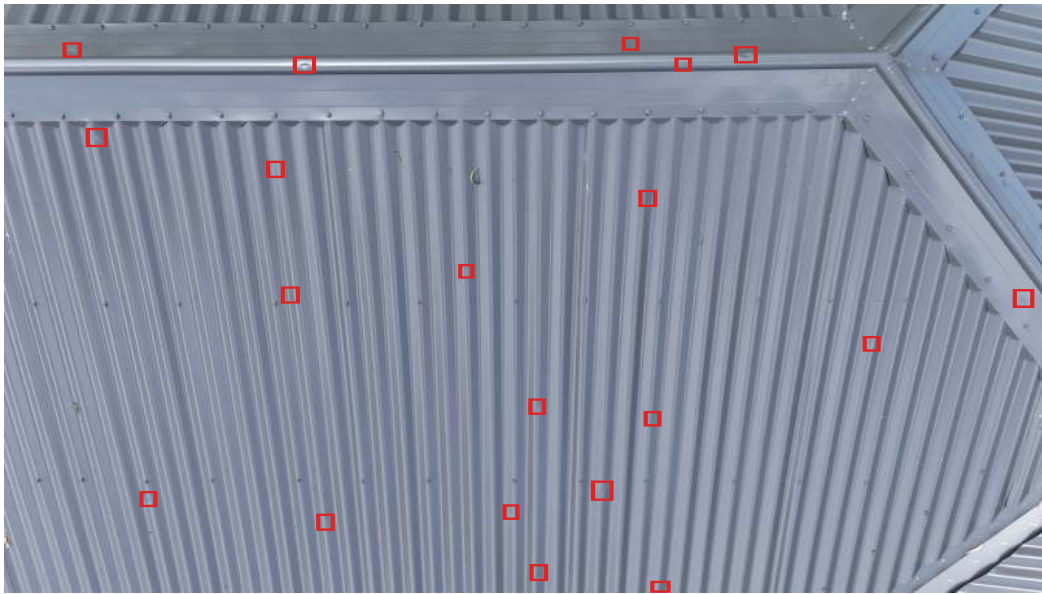
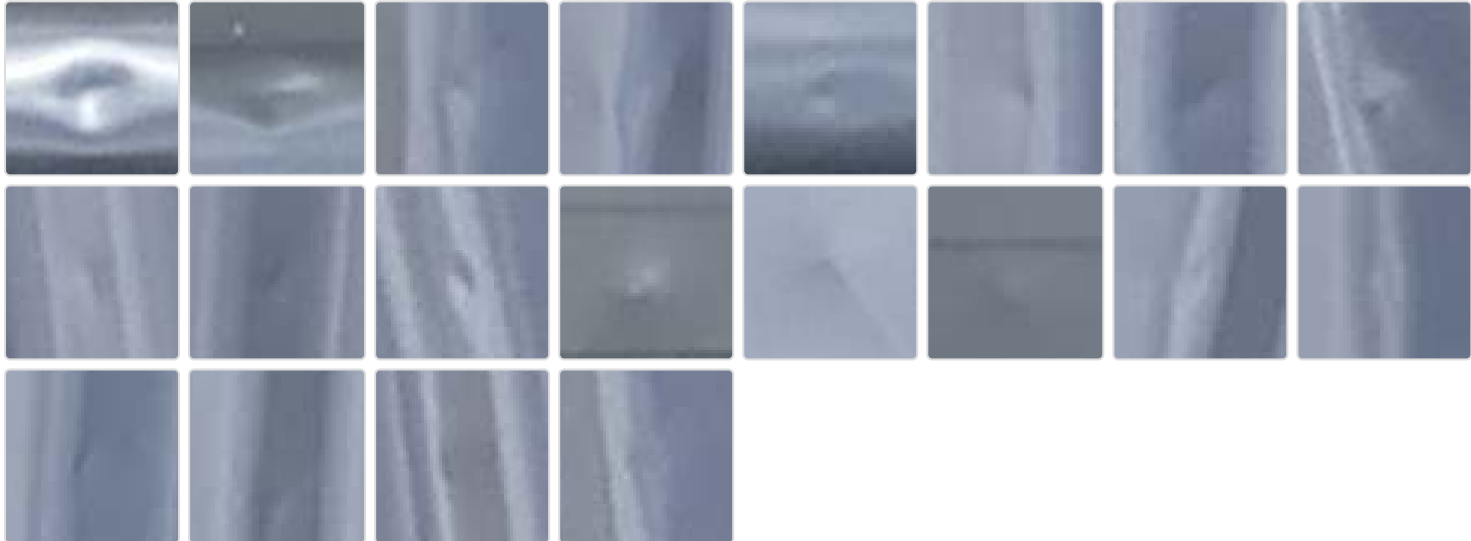
Lat: -27.5605458
Lon: 152.9012668

Hail Hit 20

Hail Hit

insurable

Description: Hails Hits have caused dents in roof & or sheet metal sheeting that can affect the structural integrity of the material depending on the size, location, and severity of the dent.

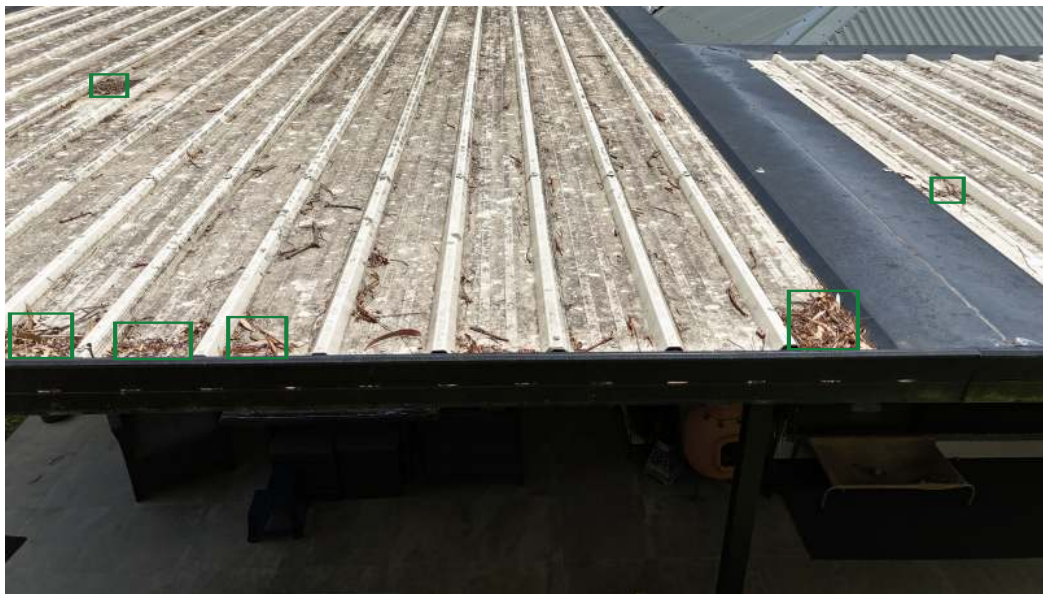
Lat: -27.5605036
Lon: 152.9014324

● Organic Debris 6

● Organic Debris

[maintenance](#)

Description: The accumulation of organic matter can block roof sheet pans, gutters, and down pipes, reducing the efficacy of the drainage system. Organic matter holds moisture, creating a corrosive environment, which accelerates the degradation of the roof, and drainage system.

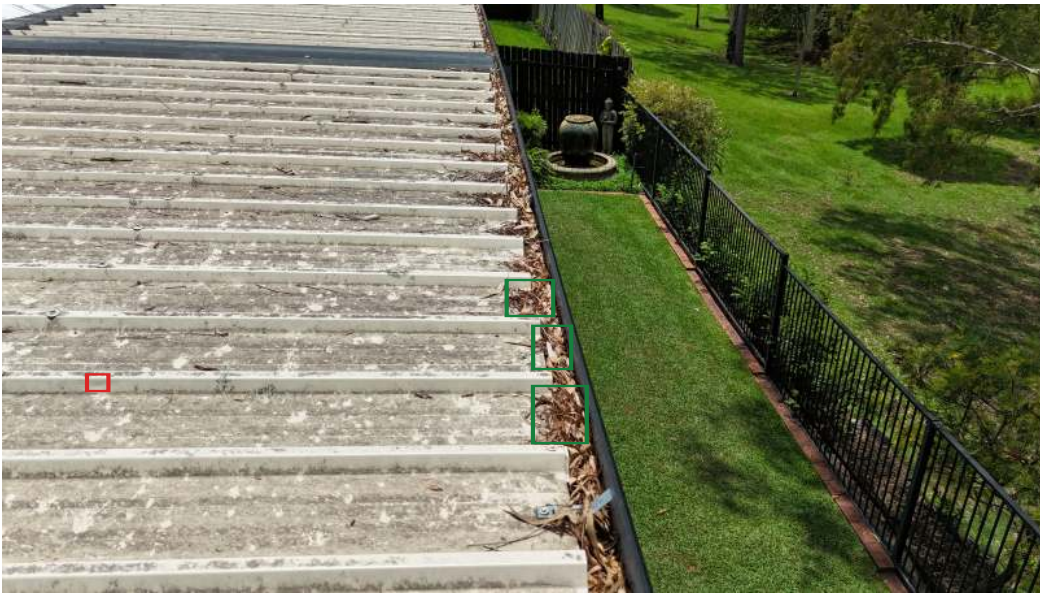
Lat: -27.5605707
 Lon: 152.9013935

- Organic Debris 3
- Hail Hit 1

● Organic Debris

maintenance

Description: The accumulation of organic matter can block roof sheet pans, gutters, and down pipes, reducing the efficacy of the drainage system. Organic matter holds moisture, creating a corrosive environment, which accelerates the degradation of the roof, and drainage system.

● Hail Hit

insurable

Description: Hails Hits have caused dents in roof & or sheet metal sheeting that can affect the structural integrity of the material depending on the size, location, and severity of the dent.
